Rose City Yacht Club Breakwater Report

November 27, 2023

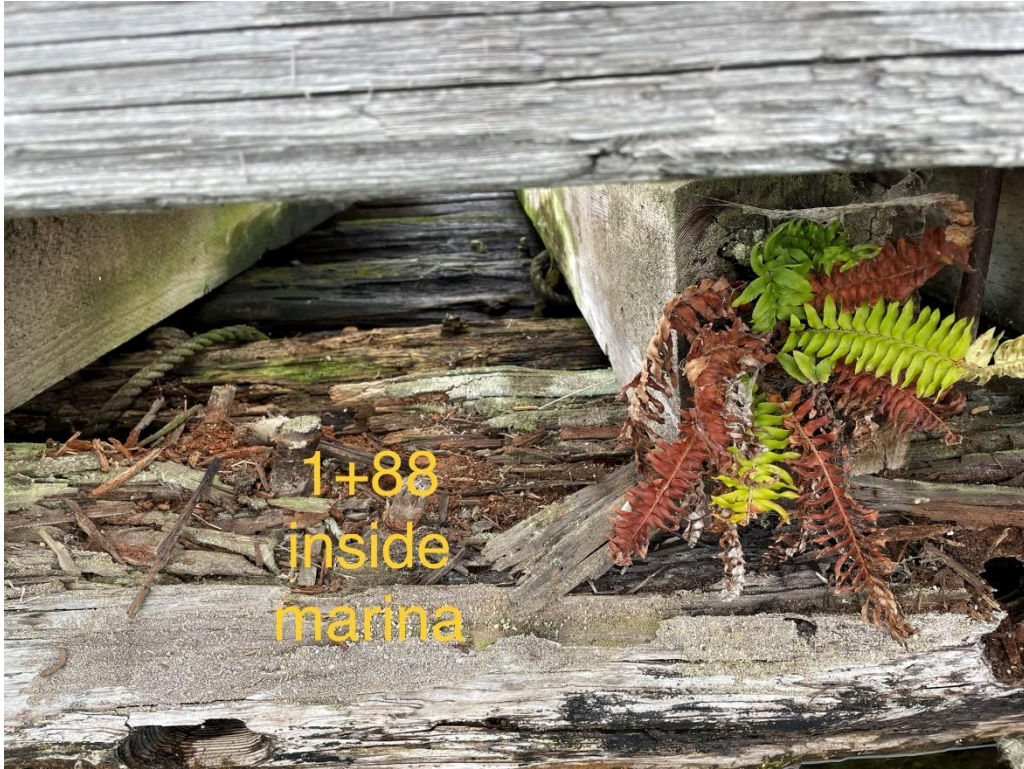
Figure 1 - Growth on Logs

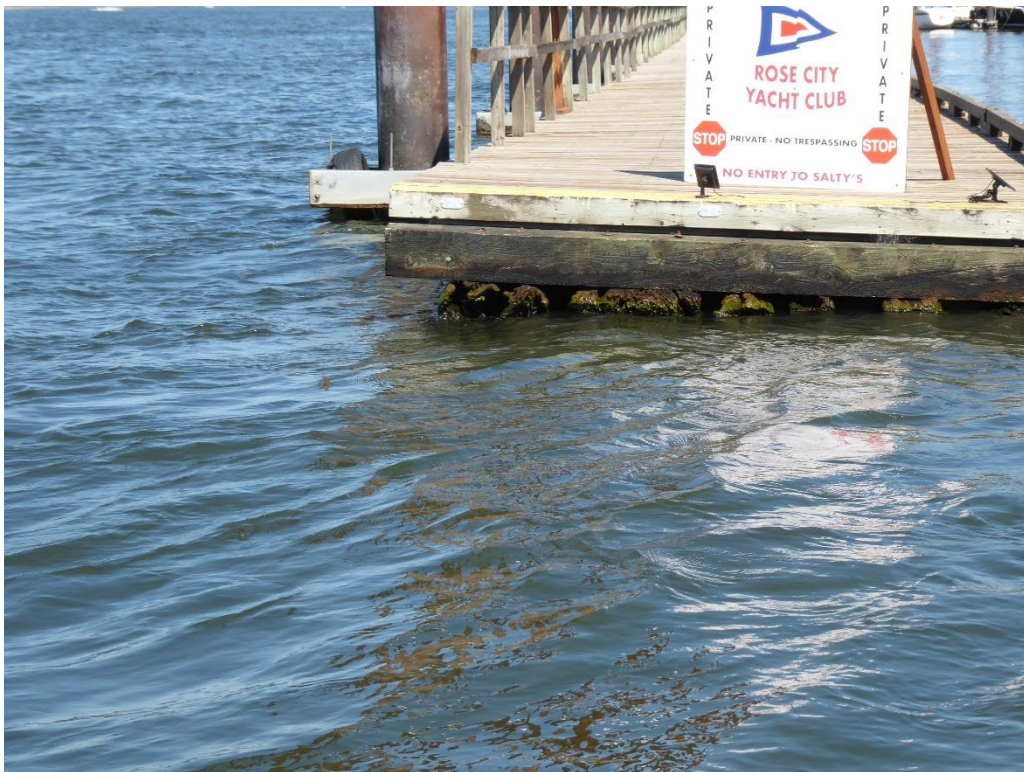
Logs – Many of the logs appear to be in relatively good shape from the splash zone down. The upper portions of most logs have deteriorated and show extensive rot. Core samples were taken to verify conditions. Some logs were in good condition while others were severely deteriorated. It is estimated that about 25% of the logs exhibit severe deterioration.

Figure 2 Deteriorated End Condition of Logs

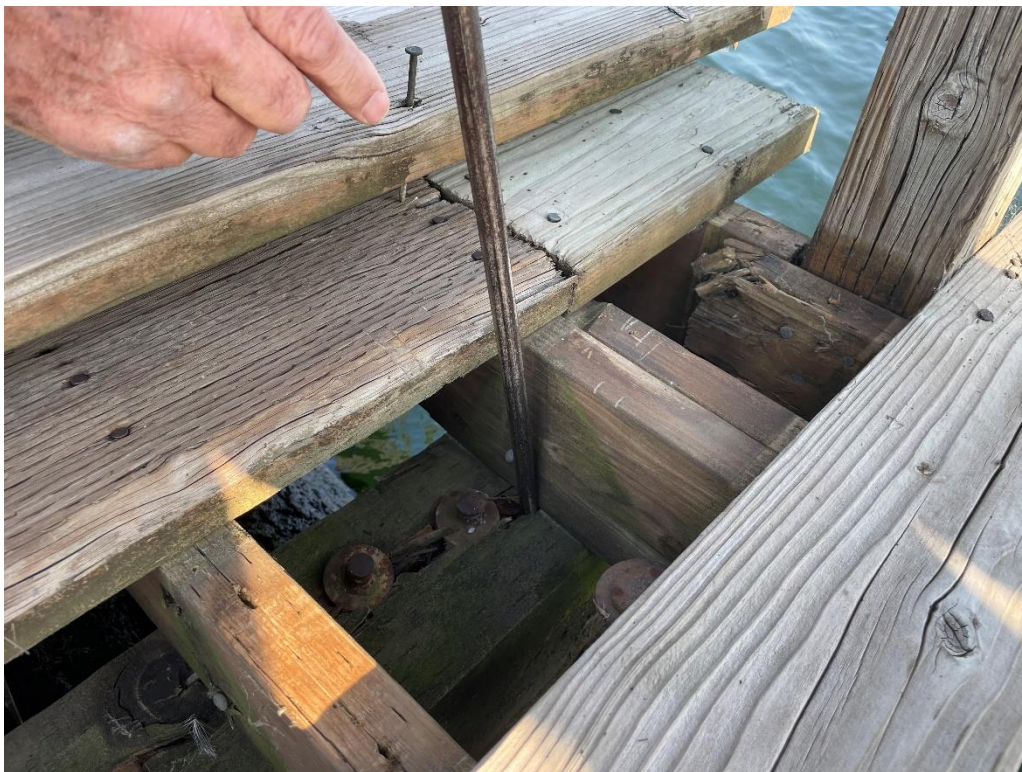
At walk one deterioration in the outer 1 – 4 inches was observed.

In the middle, deterioration throughout was observed.

At the Donaldson end half of the stringer was deteriorated.

In addition, a floating examination was conducted on the southside of the breakwater from a work boat and each visible stringer was sounded with a 2# telephone pole sounding tool. Those not considered sound were marked with yellow paint. About 2/3 were marked. However not all stringers were accessible from the work boat. The

northside of the breakwater was also examined at the workboat level and most stringers showed extensive end deterioration.

Figure 3 Deteriorated Stringers

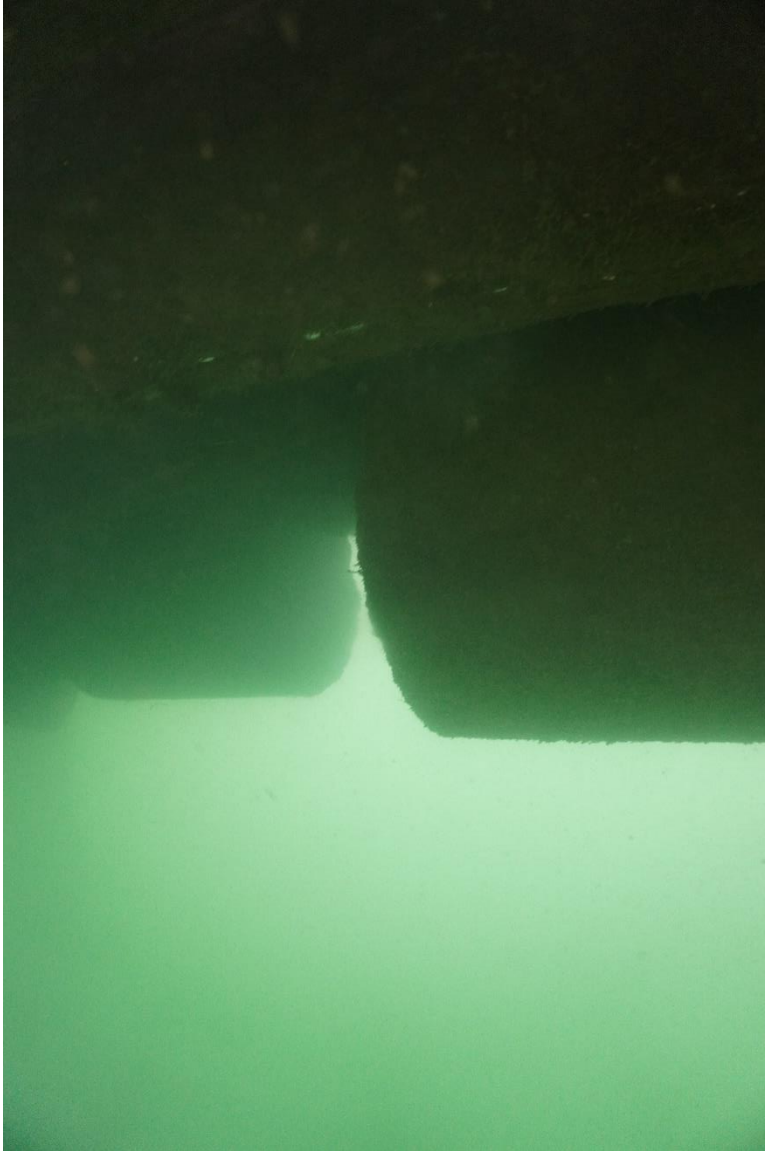
Styrofoam Floatation - There are encapsulated Styrofoam blocks under the logs at regular intervals. In addition, at irregular intervals there are unencapsulated Styrofoam cylinders under the logs. These cylinders are intact and do not evidence release of Styrofoam particles into the environment. However, it should be noted that unencapsulated Styrofoam is no longer permitted. Without this floatation it is likely that the current breakwater would not float much above the water level.

Figure 5 Styrofoam Cylinders Under Breakwater

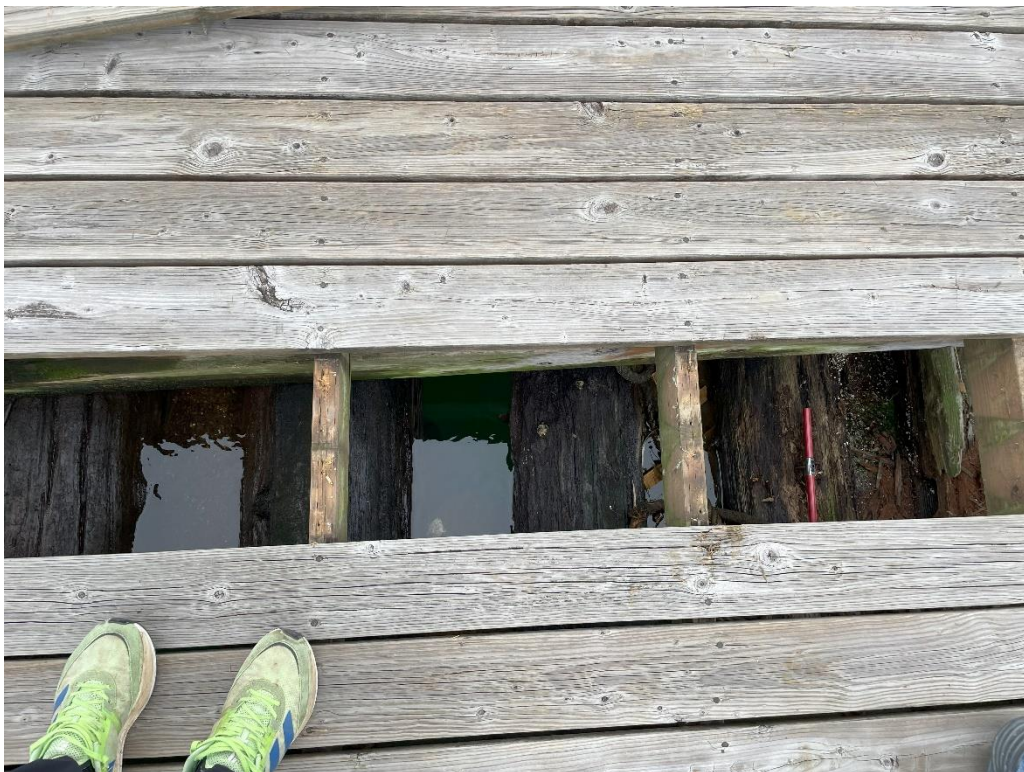
Figure 6 Deteriorated Logs with Coring Tool

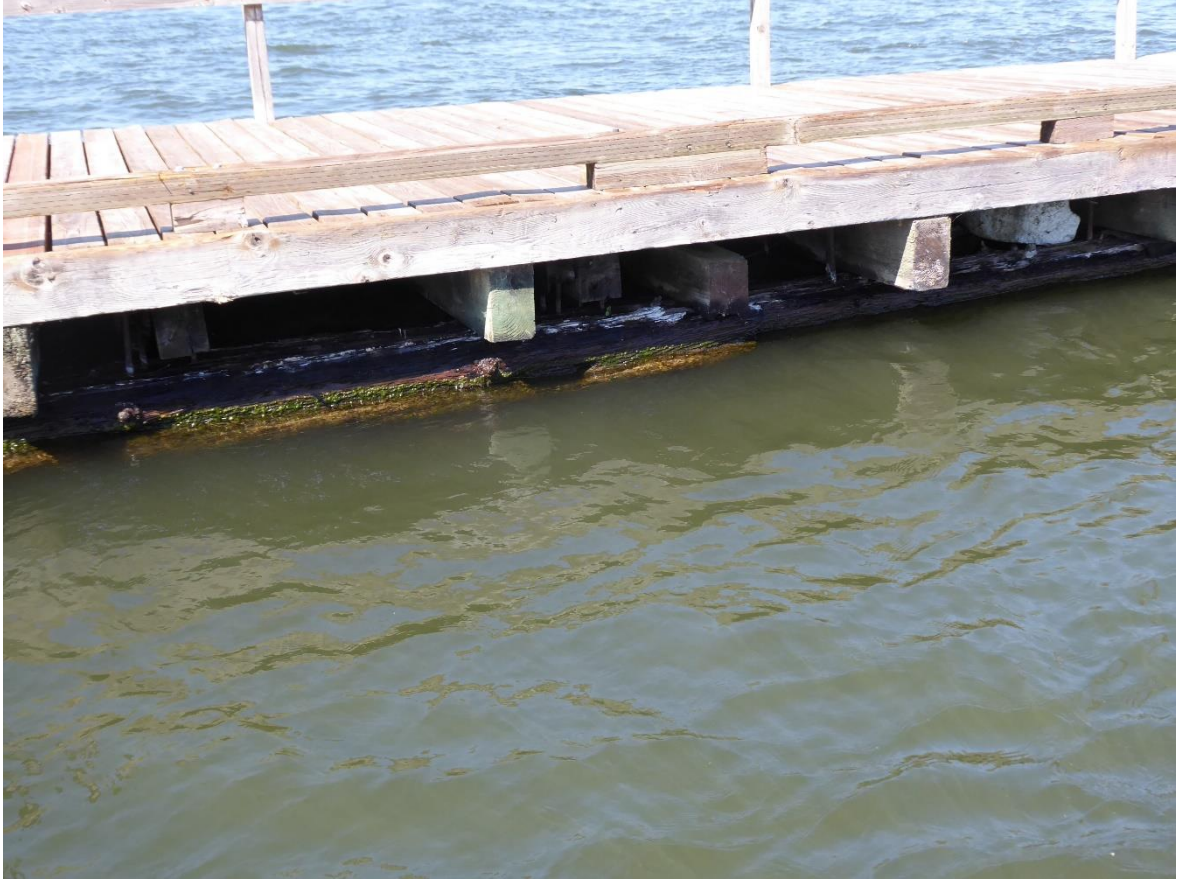
Handrail – About half is deteriorated.

Walers – All are sun damaged.

Tieup beams – All are sun damaged.

Figure 7 Handrails, Walers and Mooring Beam
